ROCKY MOUNTAIN ARSENAL
BUILDING 1727 SUMP INTERIM
RESPONSE ACTION ASSESSMENT

DRAFT FINAL TREATABILITY STUDY
JULY 1987

CONTRACT NUMBER DAAK11-84-D-0016
TASK NUMBER 30

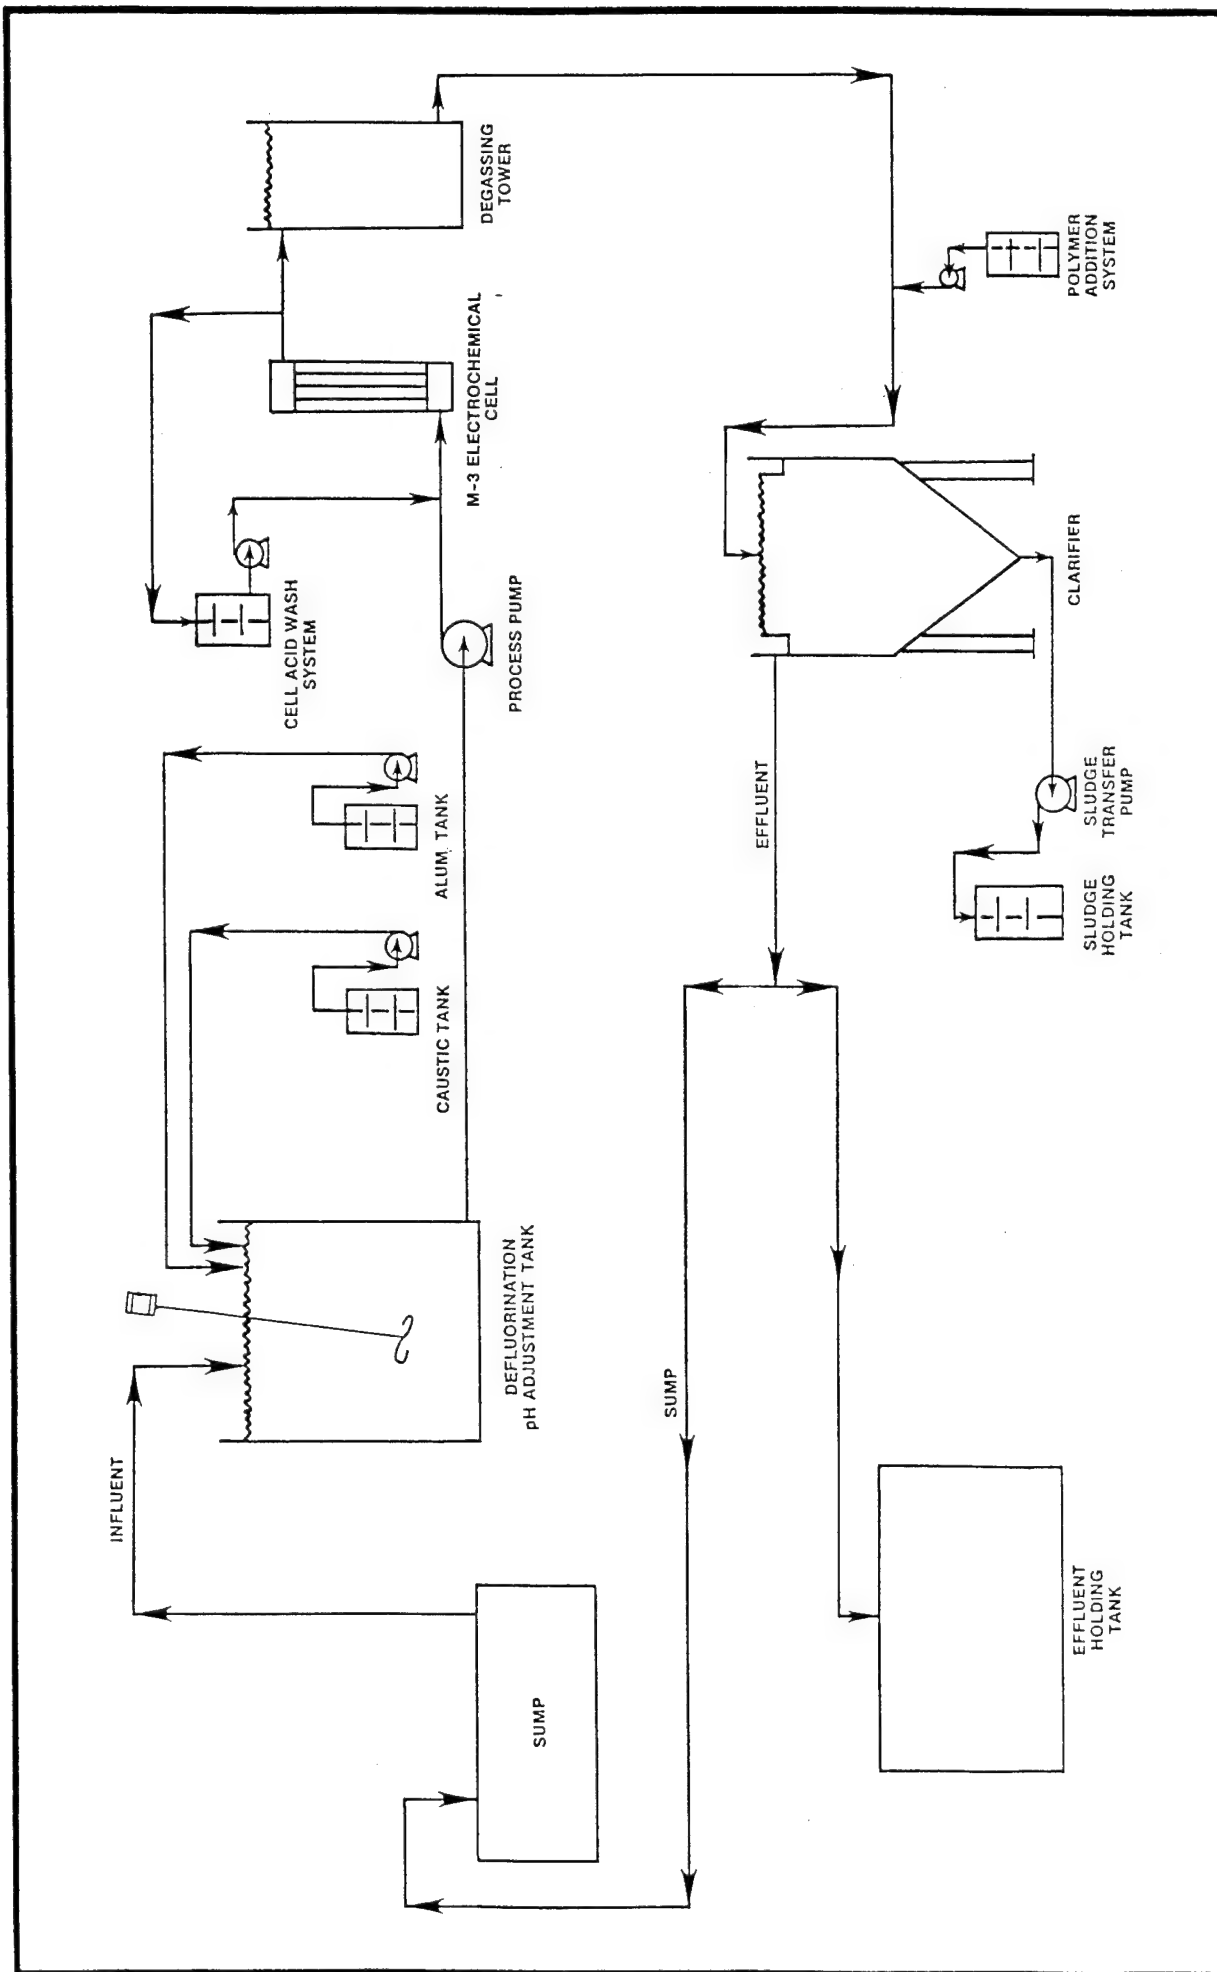
Figure 3.1-1
 PROCESS FLOW DIAGRAM-ELECTROCHEMICAL UNIT

From the pH adjustment tank the water was pumped through the electrochemical cell where ferrous hydroxide precipitate was produced. Inside the cell there were three, equally spaced, cold rolled 1/8-inch thick steel plates between which the wastewater flowed, hence the name M-3 cell. A direct current (DC) power supply was connected across the end plates turning the plates into electrodes. As the current flowed from electrode to electrode, it caused the anode to dissolve, introducing ferrous hydroxide ions and hydrogen gas bubbles into the wastewater flowing between the plates. The ferrous hydroxide, which is the useful product of the reaction, promoted the precipitation of the metals from solution. The hydrogen gas, on the other hand, served no useful purpose for treatment.

From the electrochemical cell, the water flowed to a degassing tower. This was an open-top tank which allowed sufficient time for the release of the hydrogen gas bubbles, which if not removed, would interfere with settling of the ferrous hydroxide floc in the clarifier. From the degassing tower the water flowed to the clarifier which allowed the precipitated metals to settle.

An anionic polymer was added in line to the clarifier influent as a flocculent aid to promote settling of the floc. The precipitated metals settled to the bottom of the clarifier forming a sludge with a solids content of 1 to 2 percent by weight. The clarifier supernatant was then returned to Sump 1727.

The acid wash system shown in the schematic design was used to recirculate a sulfuric acid solution through the cell to prevent the buildup of scale and sludge on the electrodes which would have an adverse effect on the electrochemical reaction. The acid wash is normally done after every 24 hours of operation.

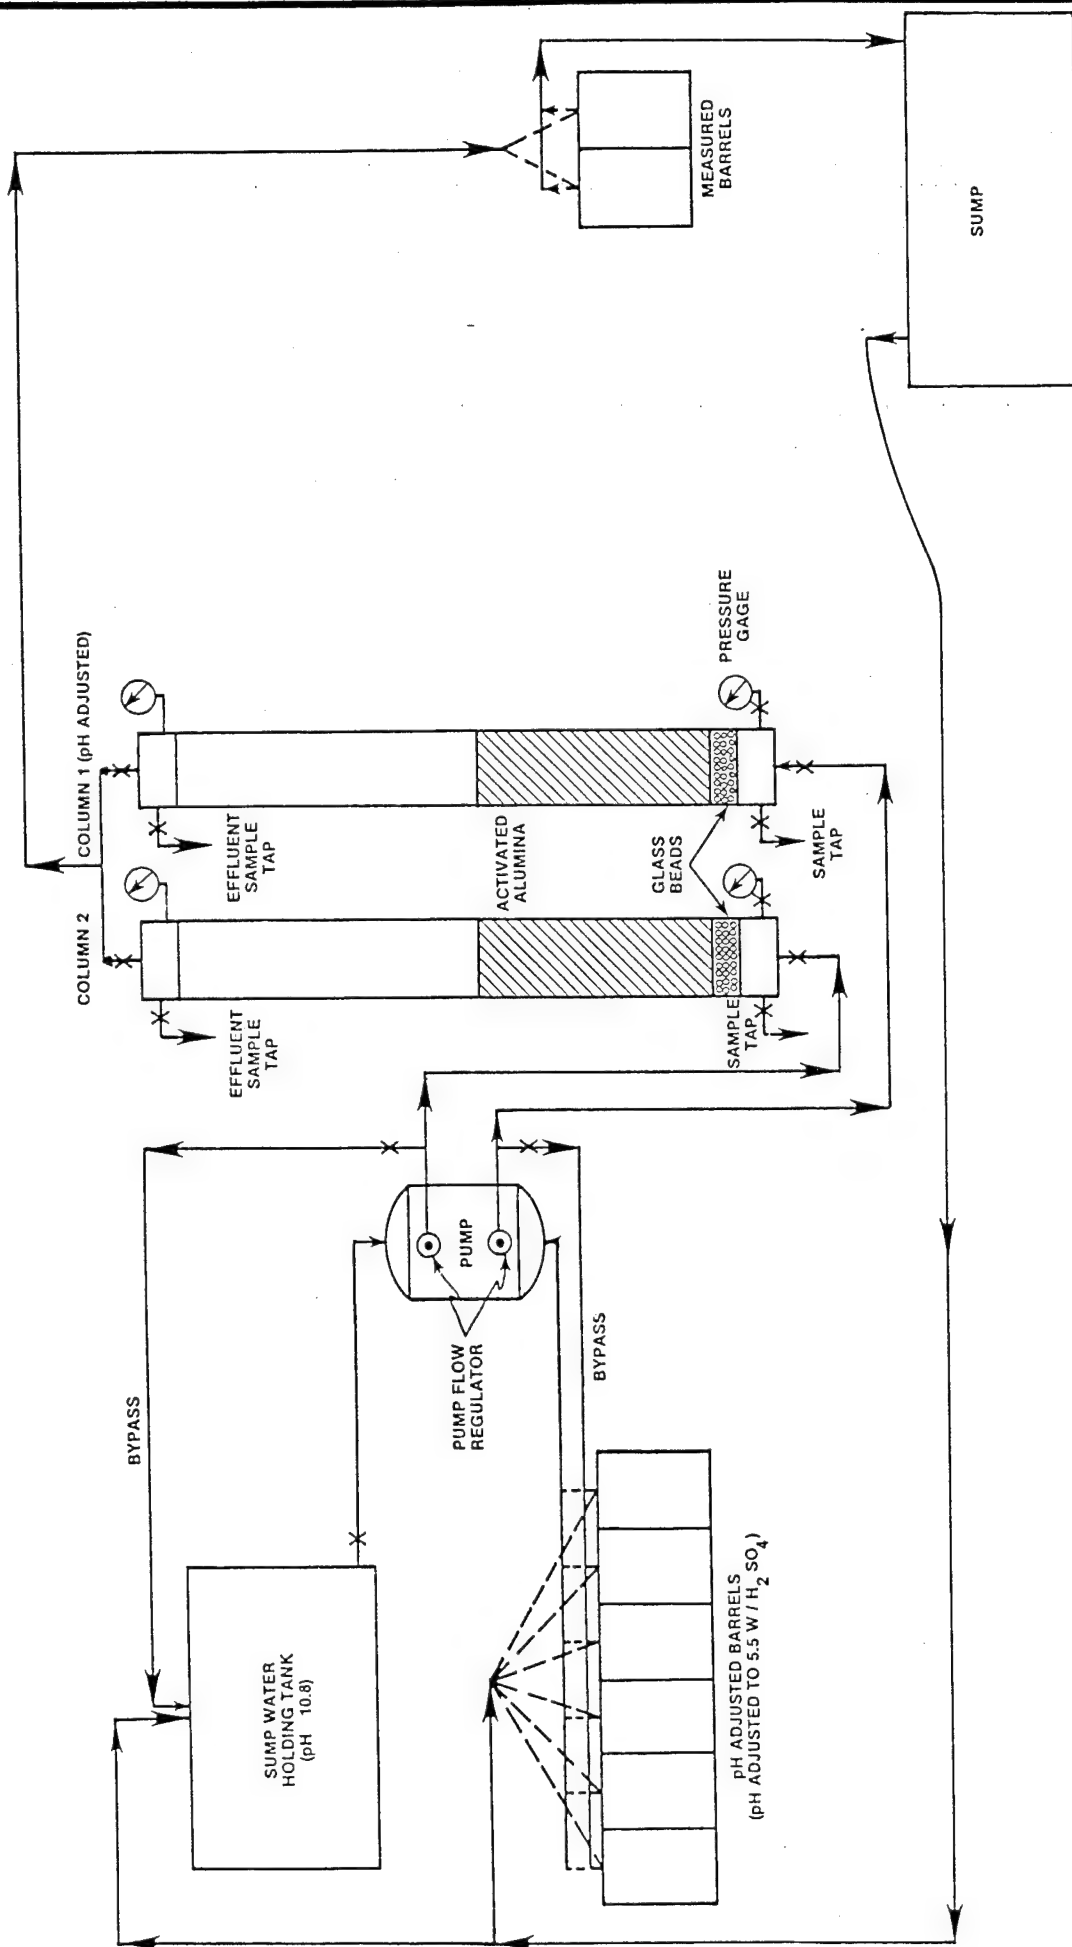
Figure 3.2-1
 ACTIVATED ALUMINA PROCESS DIAGRAM

The activated alumina test apparatus was designed to treat two separate water supplies (see Figure 3.2-1). The apparatus included a group of six barrels for one water supply and a large holding tank for the other. Water was pumped directly from the sump into either the barrels or the tank. Sulfuric acid was added to the sump water in the barrels to adjust the pH to an optimum of 5.5 ± 0.2 . The pH of the sump water in the holding tank (approximately pH 10) was not adjusted. Water was pumped from the barrels and tank by a positive pressure diaphragm pump to Columns 1 and 2, respectively. Flow regulators for each column were located at the top of the pump to control the flow into each of the columns.

The columns were 4 inches in diameter and 6 feet tall. They were run in an up-flow mode with a 10 minute bed contact time. Up-flow was used to prevent compacting or cementing effects on the treatment bed. It also ensured a consistent media contact

time and reduced channeling. The bed depth was approximately 2 feet. Glass beads were used in the columns to keep the activated alumina from backing into the fittings and to help distribute an even flow through the columns. The type of media used in the columns was the Alcoa F-1 mesh size 14-28 activated alumina. Detailed design and operating conditions of the two columns are summarized in Table 3.2-1.

Samples of influent and effluent were taken at the locations indicated in Figure 3.2-1. However, starting from the thirteenth sample, the influent samples were taken from the bypass. The influent sampling location was changed because it was determined that the water being sampled from the influent sample taps had likely contacted the column media because the flow rates were not sufficient to sample at this location without drawing water down the column from the media bed.

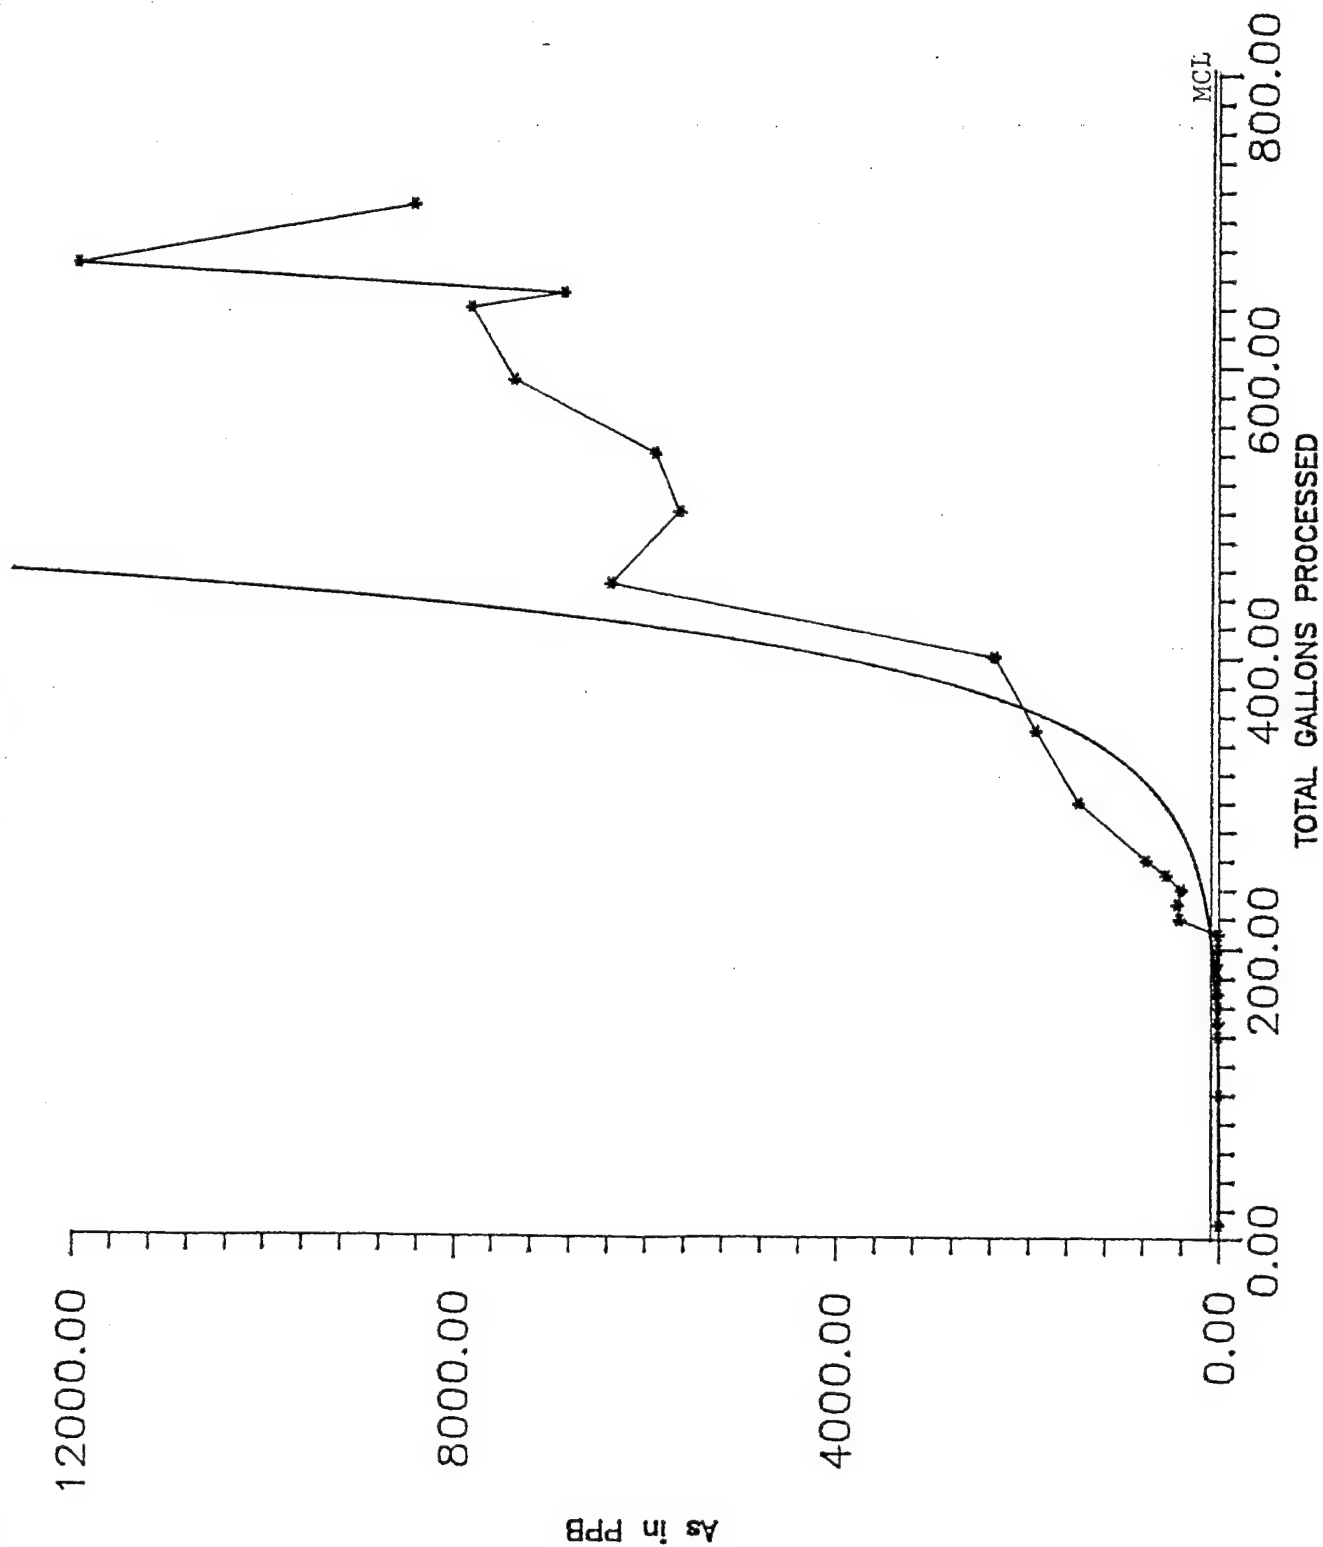
Figure 4.2-1. Plot of Column #1 Effluent, Arsenic Levels

It should also be noted that the system was put into a continuous loop for a period of time and some regeneration occurred in the columns. This can be seen in Figures 4.2-1 and 4.2-2 at approximately 650 gallons of processed effluent.

the pH adjusted system, Column 1, was able to treat the water to all of the proposed treatment levels. Approximately 200 gallons were treated in Column 1 before the concentrations of fluoride and arsenic increased above the proposed treatment levels.

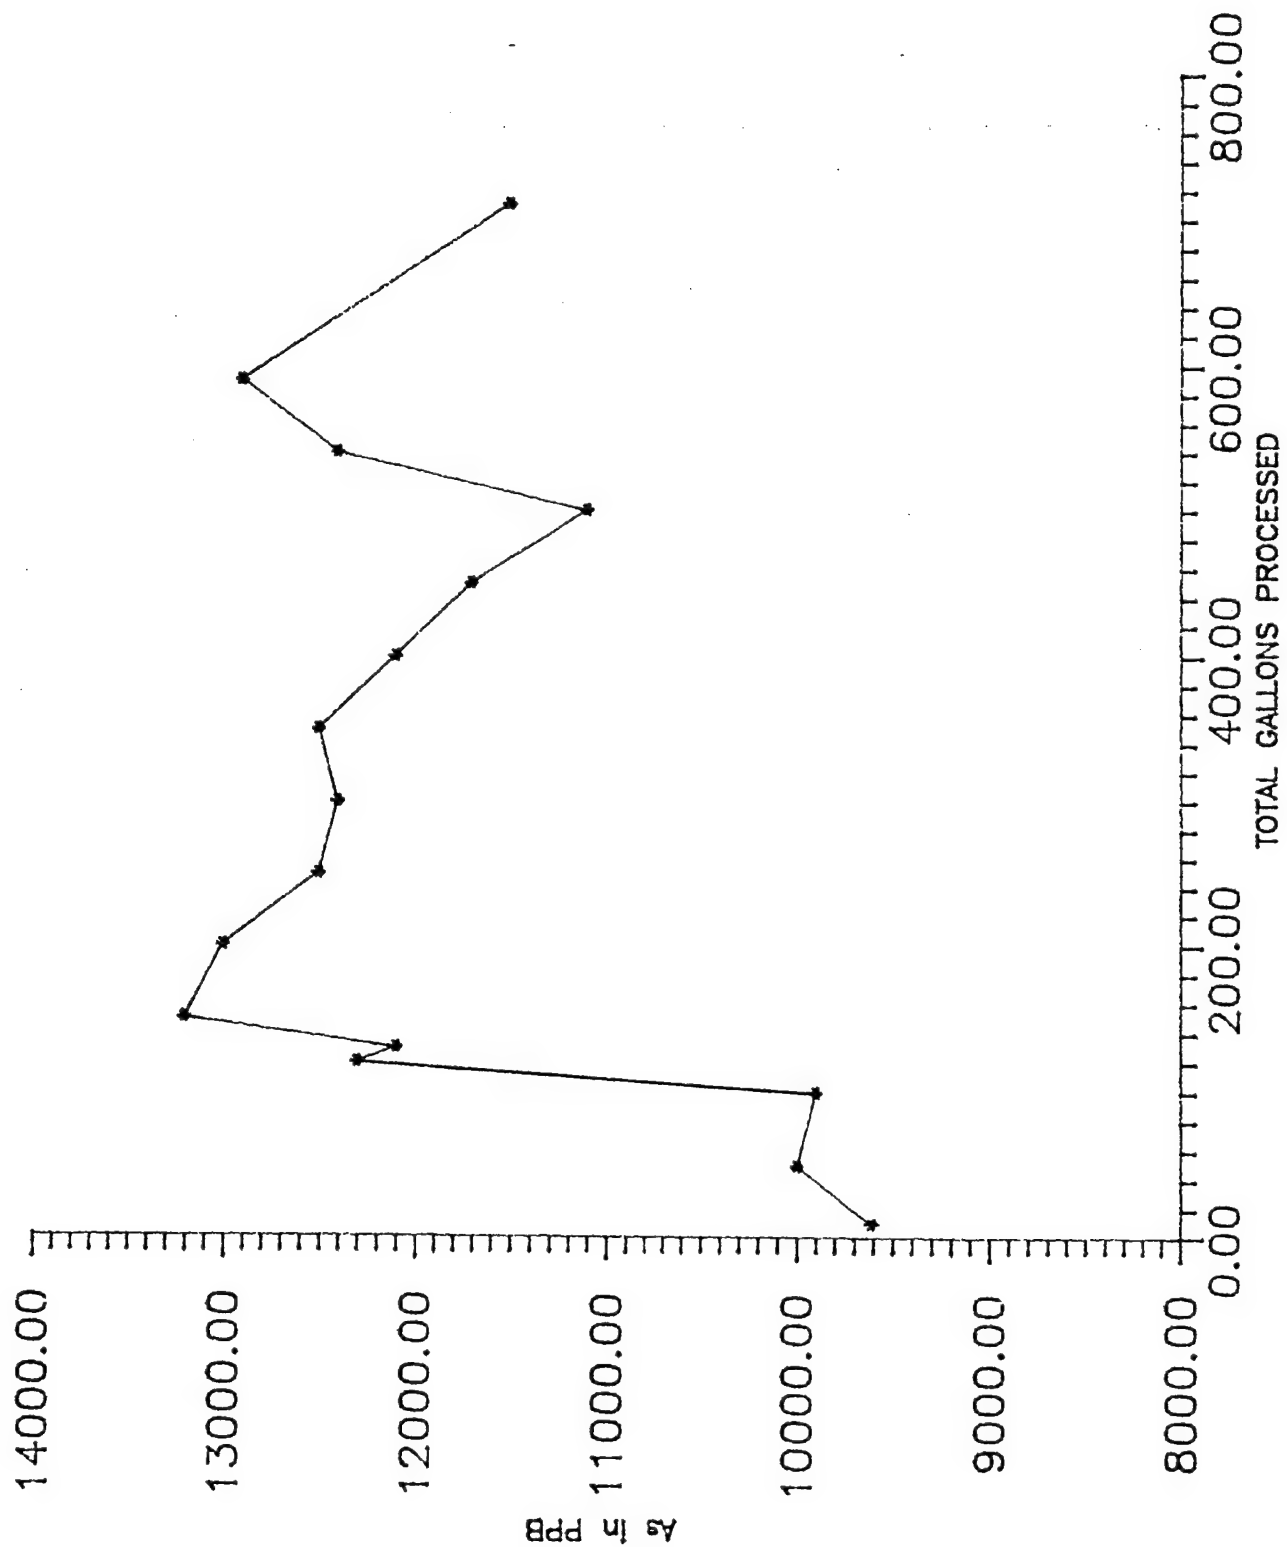
Figure 4.2-3. Plot of Column #1 Influent, Arsenic Levels

Similar to the influent cadmium and lead concentrations for the electrochemical precipitation test, the influent cadmium and lead concentrations for the activated alumina test columns were below the MCLs. Column 1 treated 161 bed volumes (210 gallons) of water to an arsenic concentration of less than 20 ug/L or parts per billion (ppb). Starting from bed volume #168 (220 gallons), the arsenic concentrations of the effluent water increased to 418 ppb and continued to increase as more water was processed. Fluoride was not adsorbed as readily as arsenic in Column 1. The results indicate that fluoride concentrations in the effluent water ranged from 4,020 to 4,540 ppb for the first 153 bed volumes (200 gallons). Again, as more water was processed the fluoride concentrations in the effluent increased. Arsenic and fluoride breakthrough curves for Column 1 effluent are presented in Figures 4.2-1 and 4.2-2, respectively. Influent arsenic and fluoride concentrations for Column 1 were plotted in Figures 4.2-3 and 4.2-4, respectively. For Column 2, the arsenic and fluoride

An event that appears to have affected the data is the change of influent sampling locations. Samples taken from the sample tap at the bottom of the columns indicate reduced concentrations of arsenic and fluoride relative to samples taken at the bypass. This may have been caused by sample contact with the activated alumina. Starting with sample #13, samples were taken at the bypass which gives a more representative influent sample.

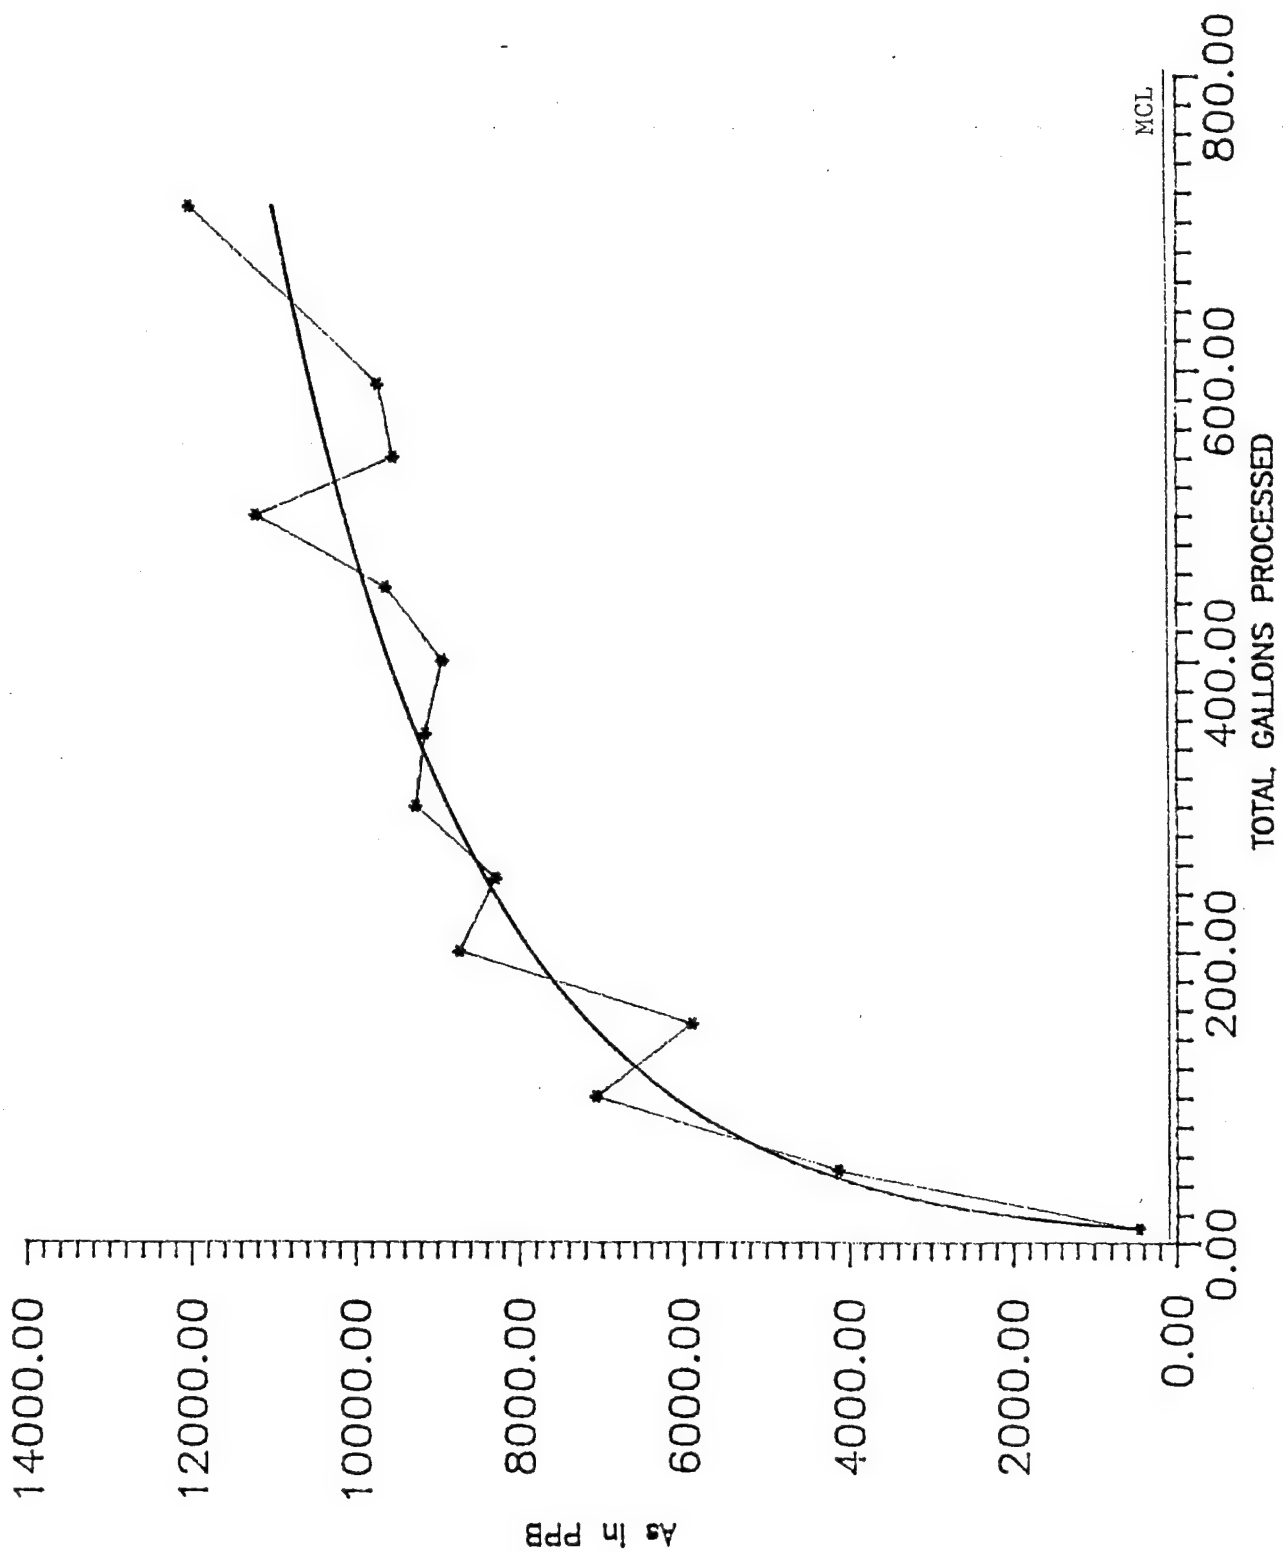
Figure 4.2-5. Plot of Column #2 Effluent, Arsenic Levels

breakthrough curves are presented in Figures 4.2-5 and 4.2-6, respectively, and the influent arsenic and fluoride levels are plotted in Figures 4.2-7 and 4.2-8, respectively.

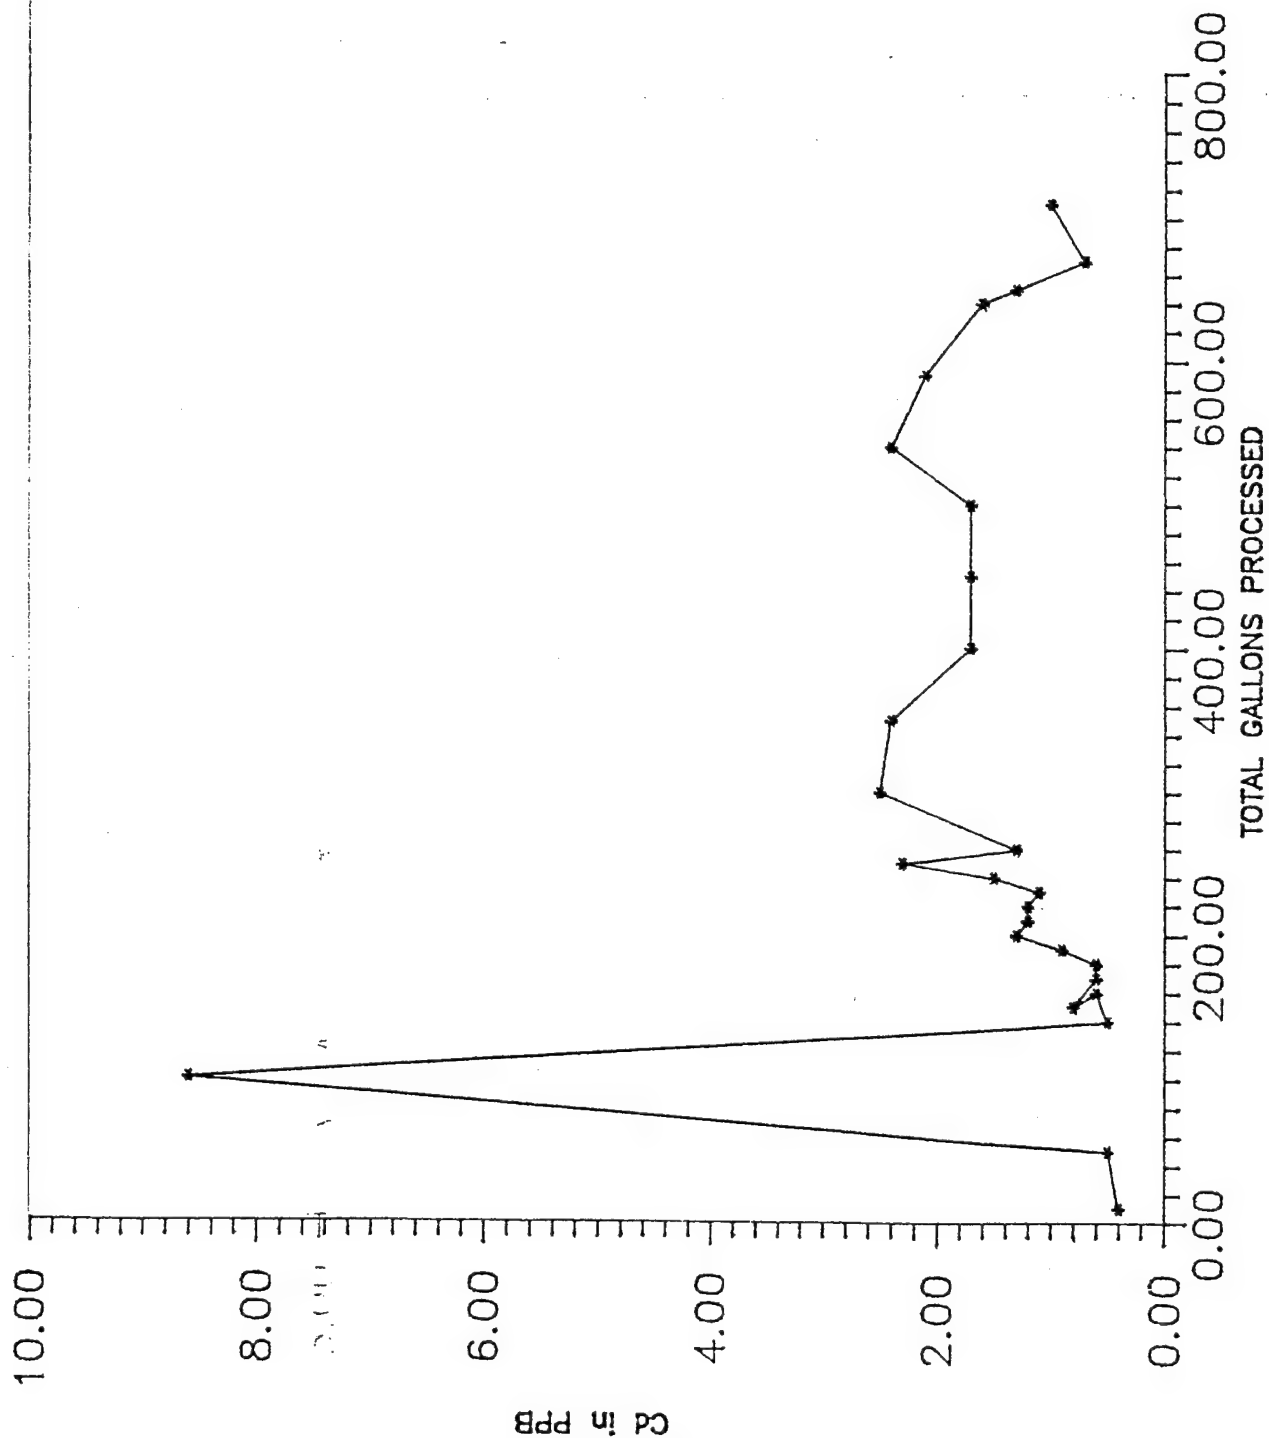
Figure 4.2-9. Plot of Column #1 Effluent, Cadmium Levels

As shown in Figures 4.2-9 and 4.2-10, which present the Column 1 effluent and influent cadmium levels, respectively, no significant cadmium removals were effected. Figures 4.2-11 and 4.2-12 present the Column 1 effluent and influent lead levels, respectively. Although these plots indicate erratic effluent lead levels, an average 67.3 percent removal for lead was achieved by Column 1.

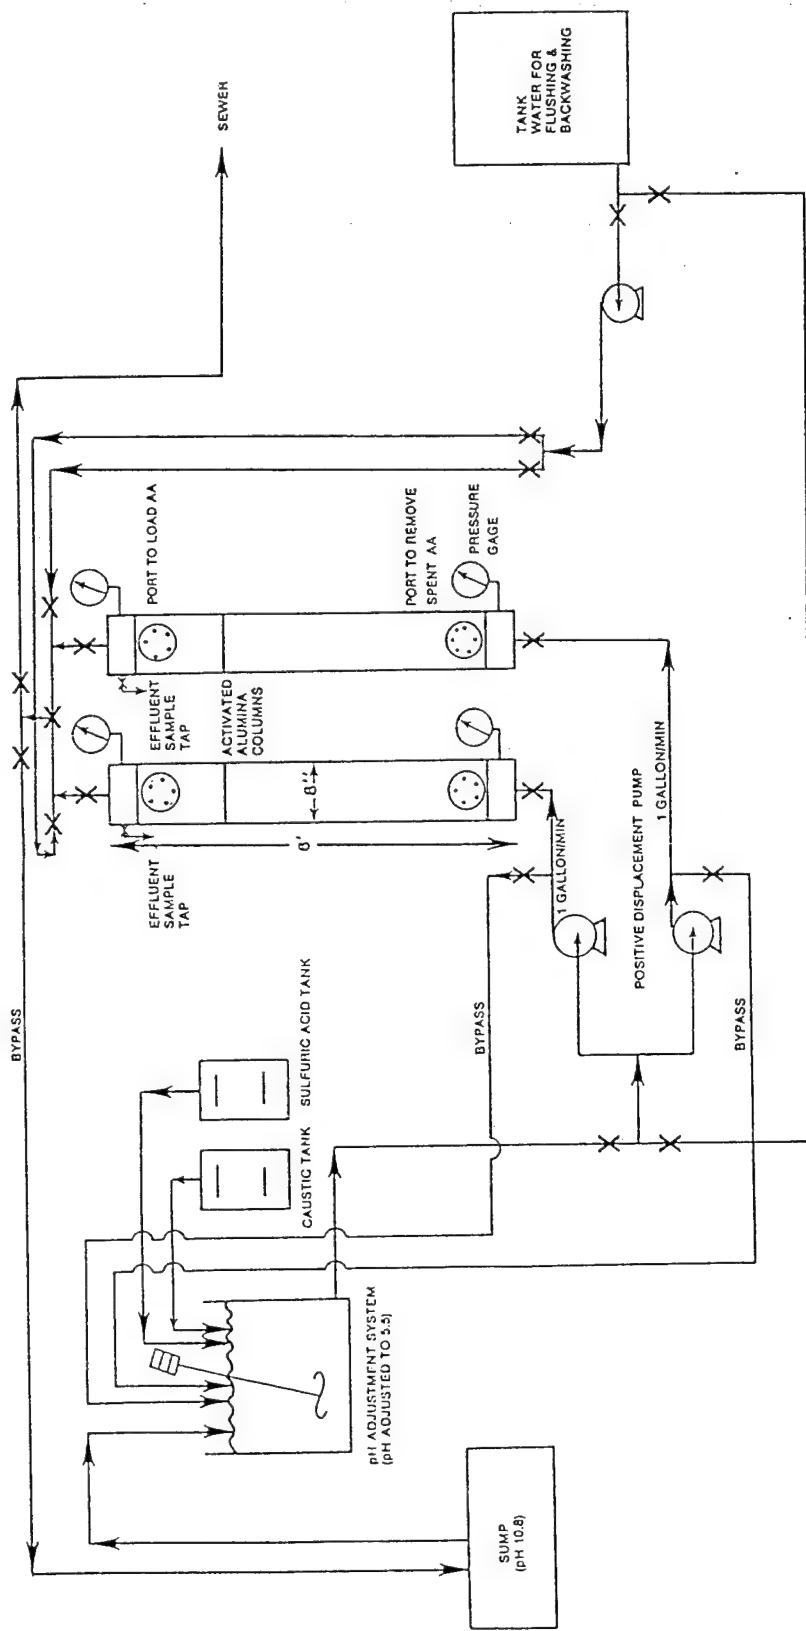
Figure 5.1-1
PROPOSED ACTIVATED ALUMINA PROCESS DIAGRAM

A conceptual design of an activated alumina system was developed from the treatability test results. It includes a pH adjust system and two activated alumina columns. The system configuration is presented in Figure 5.1-1. Sump water is pumped into the pH adjust system where the pH is adjusted to 5.5. The water level in the pH adjust tank is controlled by a level controller. The pH adjusted water is pumped into the two activated alumina columns (which operate in parallel) with two positive displacement pumps. The flow rate into each of the columns is 1 gpm. This rate takes into account a 10 minute bed contact time and a bed volume of 1.4 ft³. The dimensions of the columns are 8 inches in diameter and 6 feet high. The activated alumina is either Alcoa type F-1 mesh size 14-28 or Kaiser type A-2 mesh size 12-32. The media bed depth is 4 feet. Although not shown in Figure 5.1-1, granular activated carbon (GAC) treatment of the alumina column effluent will be provided for IMPA removal, rather than completely relying on the GAC adsorbers at the RMA sanitary wastewater system to provide IMPA removal. The GAC unit will consist of two 55-gallon drums of GAC in series.

The system effluent will be sampled regularly to monitor the system. If the analyses indicates that the levels of arsenic and fluoride are below MCL levels, then the water is discharged to the sewer. If the arsenic and fluoride levels are not below the MCL levels the water will be directed back into the sump and retreated. The system effluent will also be monitored for IMPA to determine when the GAC will need to be replaced.
